DEPARTMENT OF TRANSPORTATION

Quality Assurance and Source Inspection

Contract #: 04-0120F4Cty: SF/ALA Rte: 80 PM: 13.2/13.9File #: 99.28**WELDING INSPECTION REPORT****Resident Engineer:**Siegenthaler, Peter**Address:** 333 Burma Road**City:** Oakland, CA 94607**Report No:** WIR-024073**Date Inspected:** 26-May-2011**Project Name:** SAS Superstructure**OSM Arrival Time:** 700**Prime Contractor:** American Bridge/Fluor Enterprises, a JV**OSM Departure Time:** 1900**Contractor:** Zhenhua Port Machinery Company, Ltd (ZPMC) Chanxing Island**Location:** Shanghai, China**CWI Name:** Mr. Shi Lei**CWI Present:** Yes No**Inspected CWI report:** Yes No N/A**Rod Oven in Use:** Yes No N/A**Electrode to specification:** Yes No N/A**Weld Procedures Followed:** Yes No N/A**Qualified Welders:** Yes No N/A**Verified Joint Fit-up:** Yes No N/A**Approved Drawings:** Yes No N/A**Approved WPS:** Yes No N/A**Delayed / Cancelled:** Yes No N/A**Bridge No:** 34-0006**Component:** OBG Segment**Summary of Items Observed:**

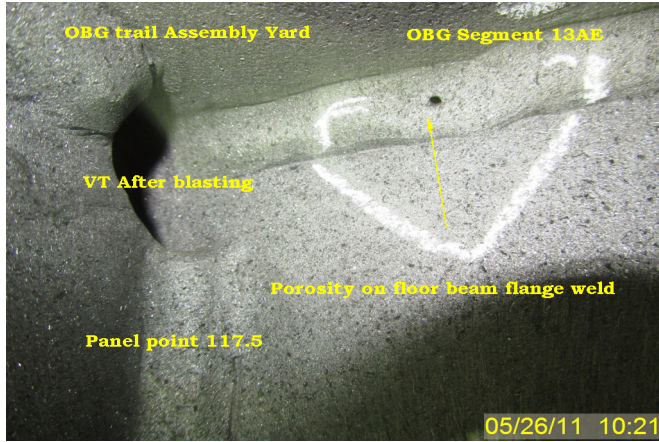
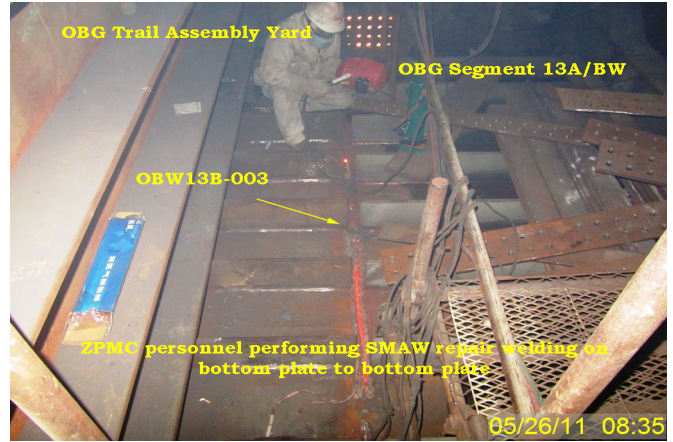
This QA Inspector performed a preliminary random visual inspection on OBG Segment 13AE, after the grit blast of the interior components of the deck panel, floor beams and corner assemblies of this segment. The panel point is identified as PP117.5 to 118 at counter weight side of OBG Segment 13AE. Areas of visual weld defects that will require welding were taped and will be repaired after the coating is applied. ZPMC QC personnel are aware of these areas and were present during the inspection. See the attached picture.
